**STRUCTURAL INVESTIGATION  
OF  
SPARTAN STADIUM  
PORTSMOUTH, OHIO**

**PORTSMOUTH CITY SCHOOLS  
923 FINDLAY STREET  
PORTSMOUTH, OHIO 45662**

**January 19, 2007**

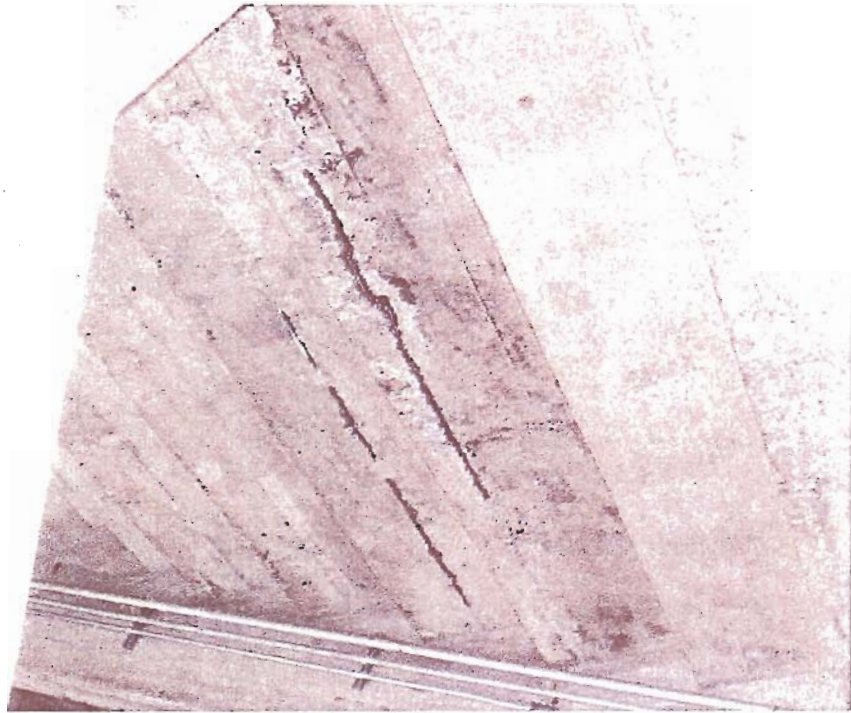
**Photo #1**

I first examined the main stadium. Water leakage has caused a great deal of cracking and spalling of the concrete throughout the entire underside of the structure. There is also significant efflorescence, which is the leaching of water-soluble calcium hydroxide from the concrete. It is characterized by the white staining of the concrete. Photos 1 and 2 on the next page offer a fair representation of the type of damage witnessed on the underside of the concrete deck. In photo #1, the bottom of the concrete steps show signs of cracking, spalling, and efflorescence. Photo #2 shows significant cracking in the concrete structural member. This corrosion is being initiated from the top surface as water leaks into the structure, and is often discovered too late. By the time the water leaches all the way to the bottom of the structure to begin corroding the rebar, significant damage has already been done to the concrete above.

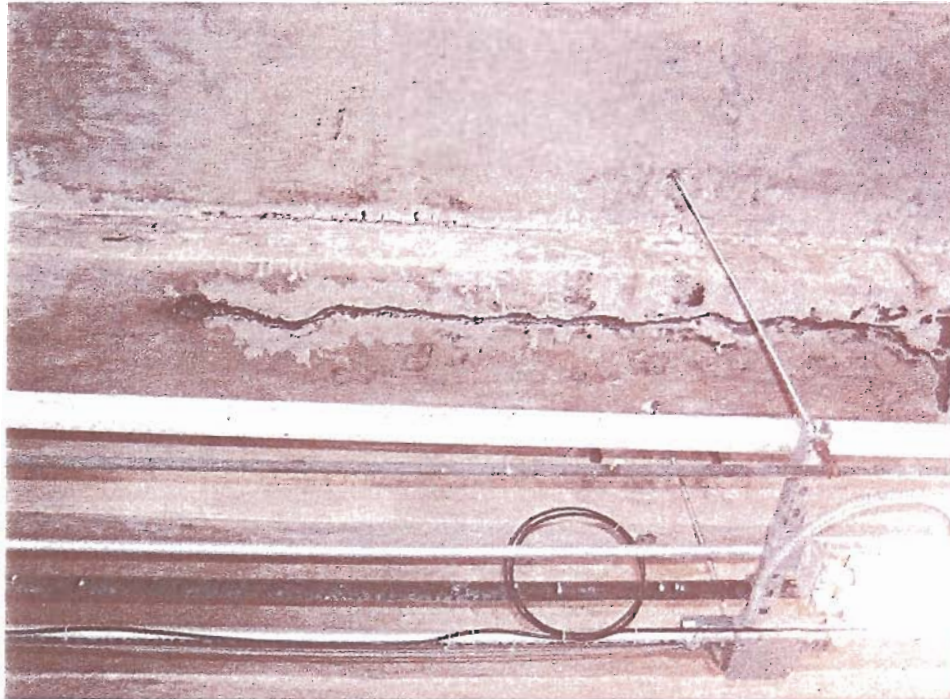
**Photo #3**

Previous repairs were made to some of the cracks about 6-7 years ago on the underside of the structure. However, as seen in photo #3 below, the repairs are failing and the cracks are reopening. This indicates that the cracking is still active, and that water continues to leak into the structure.

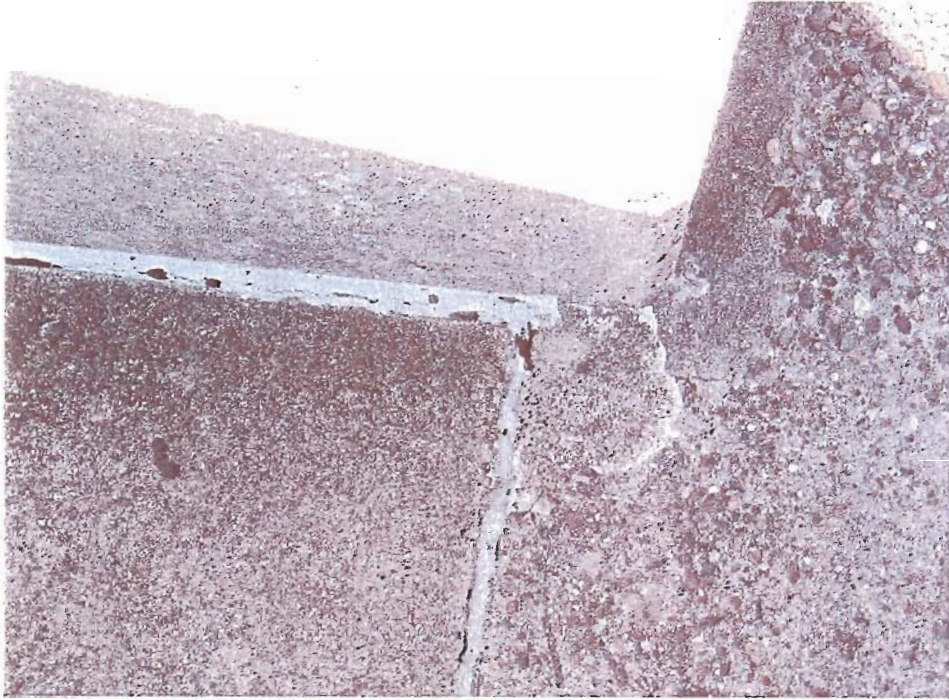
**Photo #4**

I examined the top of the structure to examine some of the areas where the leakage is occurring. Previous joints and cracks had been caulked in the past repairs, however in almost every case, the repaired areas had reopened allowing water to enter the structure. Photos 4 and 5 on the next page show typical examples of the how the previous caulking is deteriorating. The caulk is separating from the surrounding concrete in photo #4, allowing the entry of water. In photo #5, a crack is propagating through the caulking.

Should all of the testing come back with positive results, the repairs could then proceed. The minimum suggested repairs are as follows. First, the top and exterior surfaces of the concrete will need to be patched, caulked, and resealed. This would include the removal of all previous patching and caulking that is failing. It is also suggested that the all exterior concrete surfaces have a water sealant applied to assist in preventing the future entry of water into the structure. All of the concrete on the underside of the structure could then be repaired. This would include the chipping, cleaning, and epoxy grouting of all cracks and spalls. Due to the extent of damage, the total cost of these procedures could easily exceed \$1,000,000 to \$1,500,000. Once all of the repairs are made, a yearly maintenance schedule will have to be developed to maintain the integrity of the structure. Due to the age of the stadium, it is expected that leaks will continue to develop. This maintenance program can be expected to cost in the range of \$50,000 to \$100,000 per year.

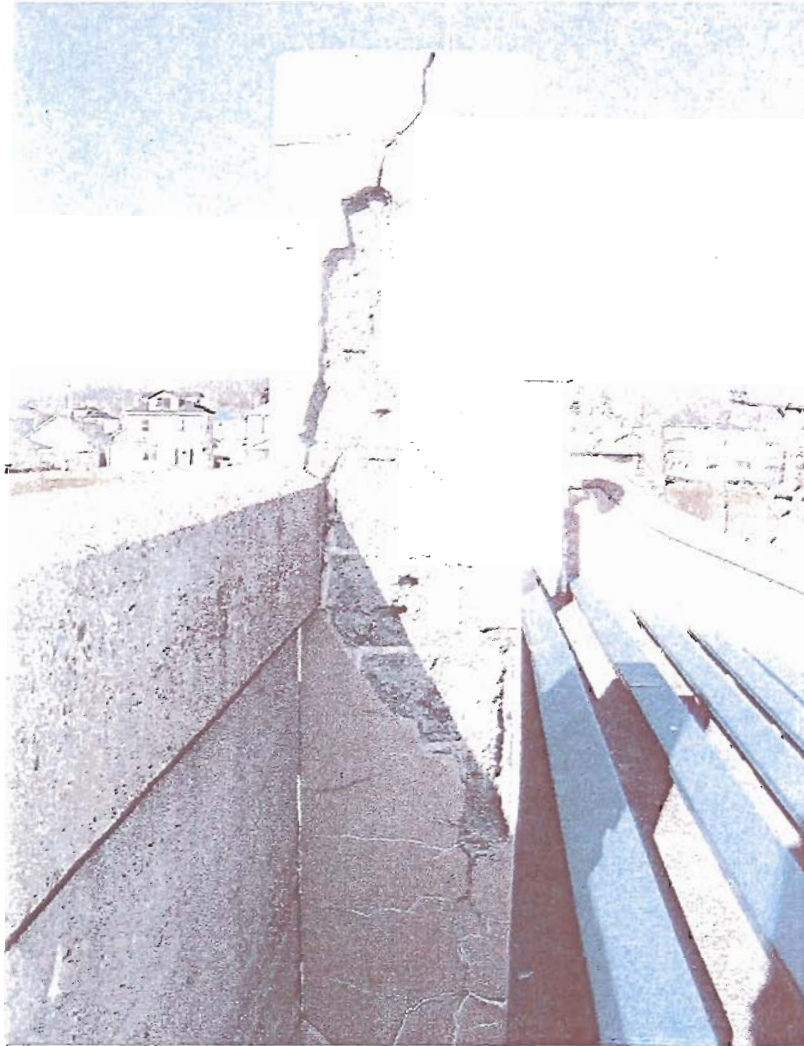
**Photo #6**

The pilasters at the top of the stadium are also experiencing a great deal of distress, as can be seen in photo #6 below. An exterior coating had been added to the pilaster, which has severely deteriorated. The condition of the pilaster below is also questionable, as it has experienced significant water damage.

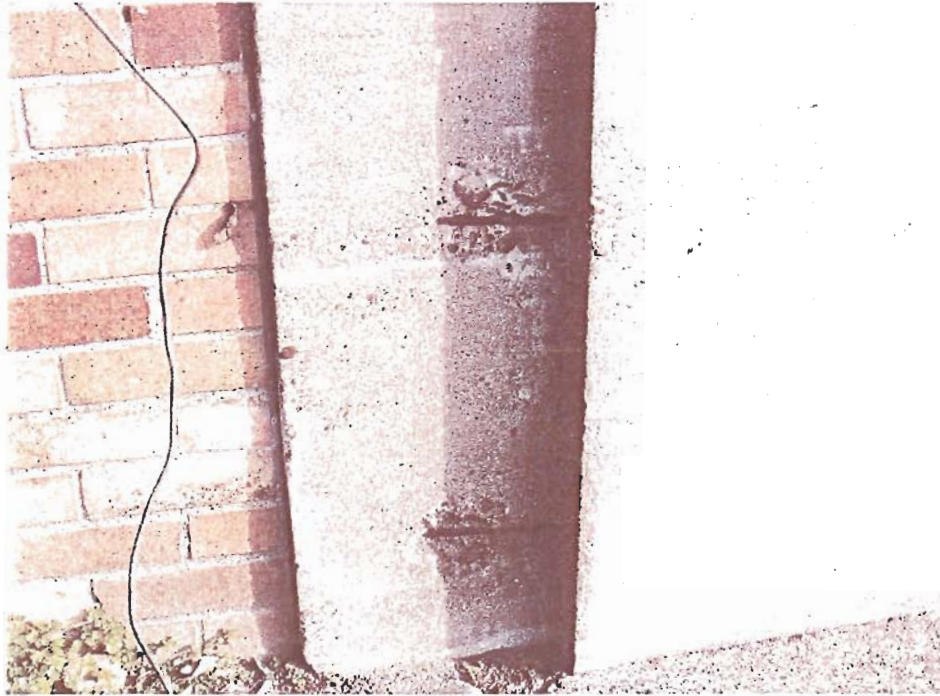
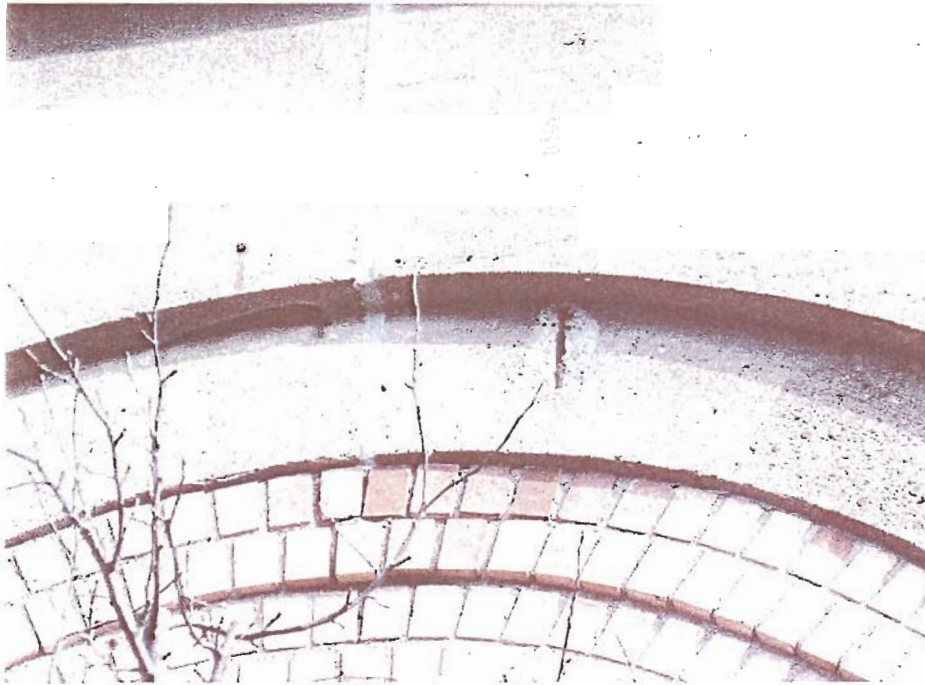
There are several other areas on the front facade of the main stadium where the concrete has deteriorated to the point of exposing the rusted rebar beneath. This condition is seen on photos 7 and 8 on the next page.

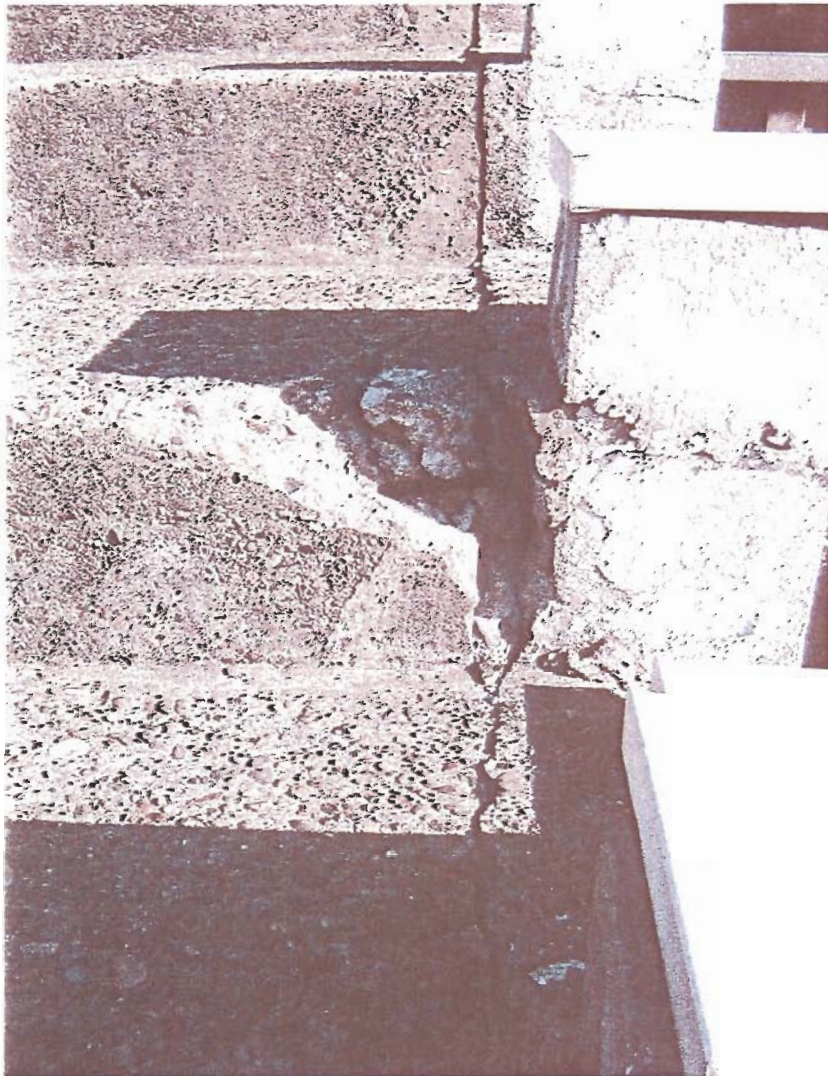
**Photo #9**

I next examined the visitors bleachers. Huge concrete failures have occurred within the structure, rendering them unsafe. The photos below, and on the next page, are indicative of the severity of the damage throughout the bleachers. There is no evidence of any maintenance ever being done to the bleachers. In photo #9 below, the concrete damage can be seen as evidenced by the cracking and spalling, as well as the exposed rusted rebar. Photo #10 shows concrete shear failure along the supporting stairs, and photo #11 shows additional damage.

Finally, the visitor bleachers are beyond repair. They are unsafe, and shall no longer be used. They will need to be demolished, and a new structure built in it's place. The cost of replacement will vary greatly depending on size and materials chosen, but will generally be in the neighborhood of \$160 per seat.

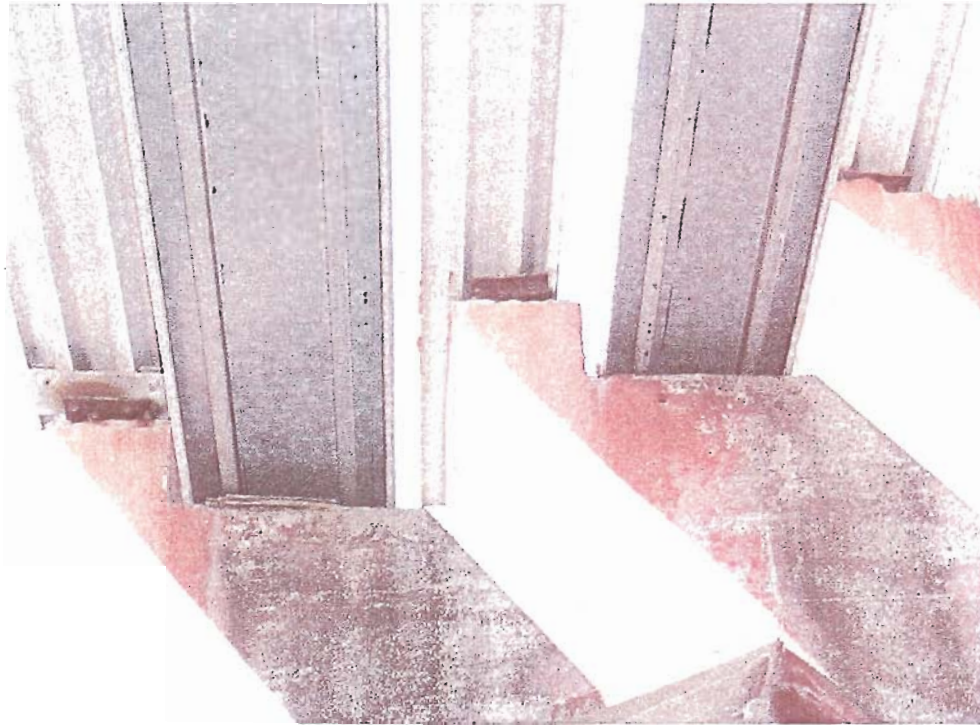
**Photo #12**

The majority of the aluminum bleacher seats are no longer attached to the concrete supports. A few are still attached with steel angles, but the majority are merely resting on the concrete with no means of attachment. In photo #12 below, holes in the concrete can be seen where an angle used to be attached to the aluminum planks.
